Lake Eden Eurasian Water Milfoil Inventory

August 30, 2022

ARROWWOOD ENVIRONMENTAL
950 BERT WHITE ROAD
HUNTINGTON, VT 05462
(802) 434-7276 FAX: (802) 329-2259

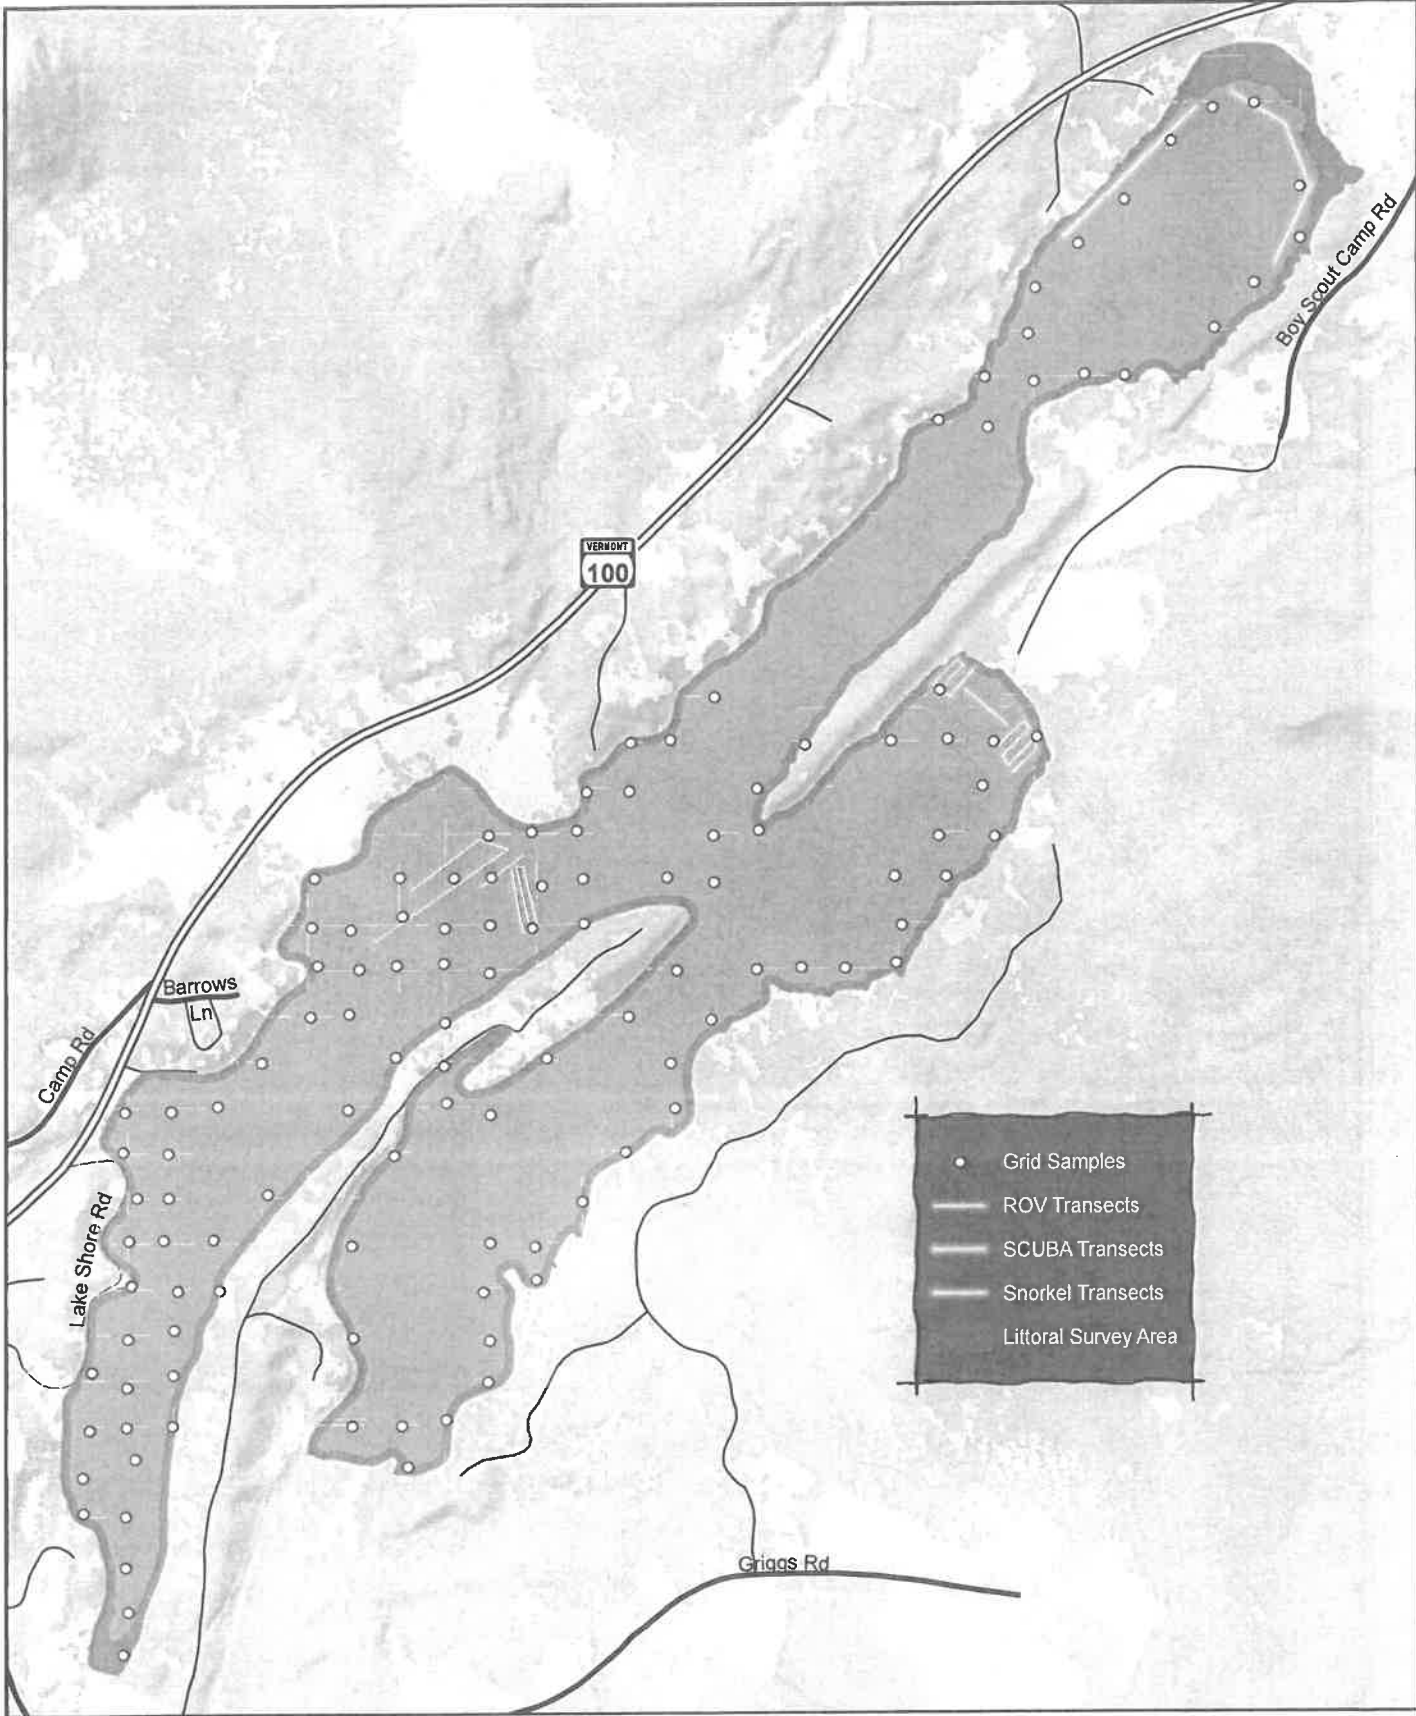
Lake Eden: Sample Locations 2022

The entire perimeter of the lake was circumnavigated in a motor boat and the littoral zone was visually surveyed for the presence EWM. Water visibility allowed for the survey of areas 8 feet deep and less with this method. The map in Appendix 2 shows the areas that were surveyed using this method. When EWM was detected, a GPS point was taken along with a count of the number of plants present and the water depth.

collected from a total of 123 grid points. Locations of the grid points are shown on the map in Appendix 2.

conducted in deeper areas (8'-15' depths) where viewing EWM was only visible while underwater. The locations of underwater transects were selected based on the vicinity of known EWM and the presence of appropriate habitat in deeper areas. The locations of the underwater transects is shown on the map in Appendix 2.

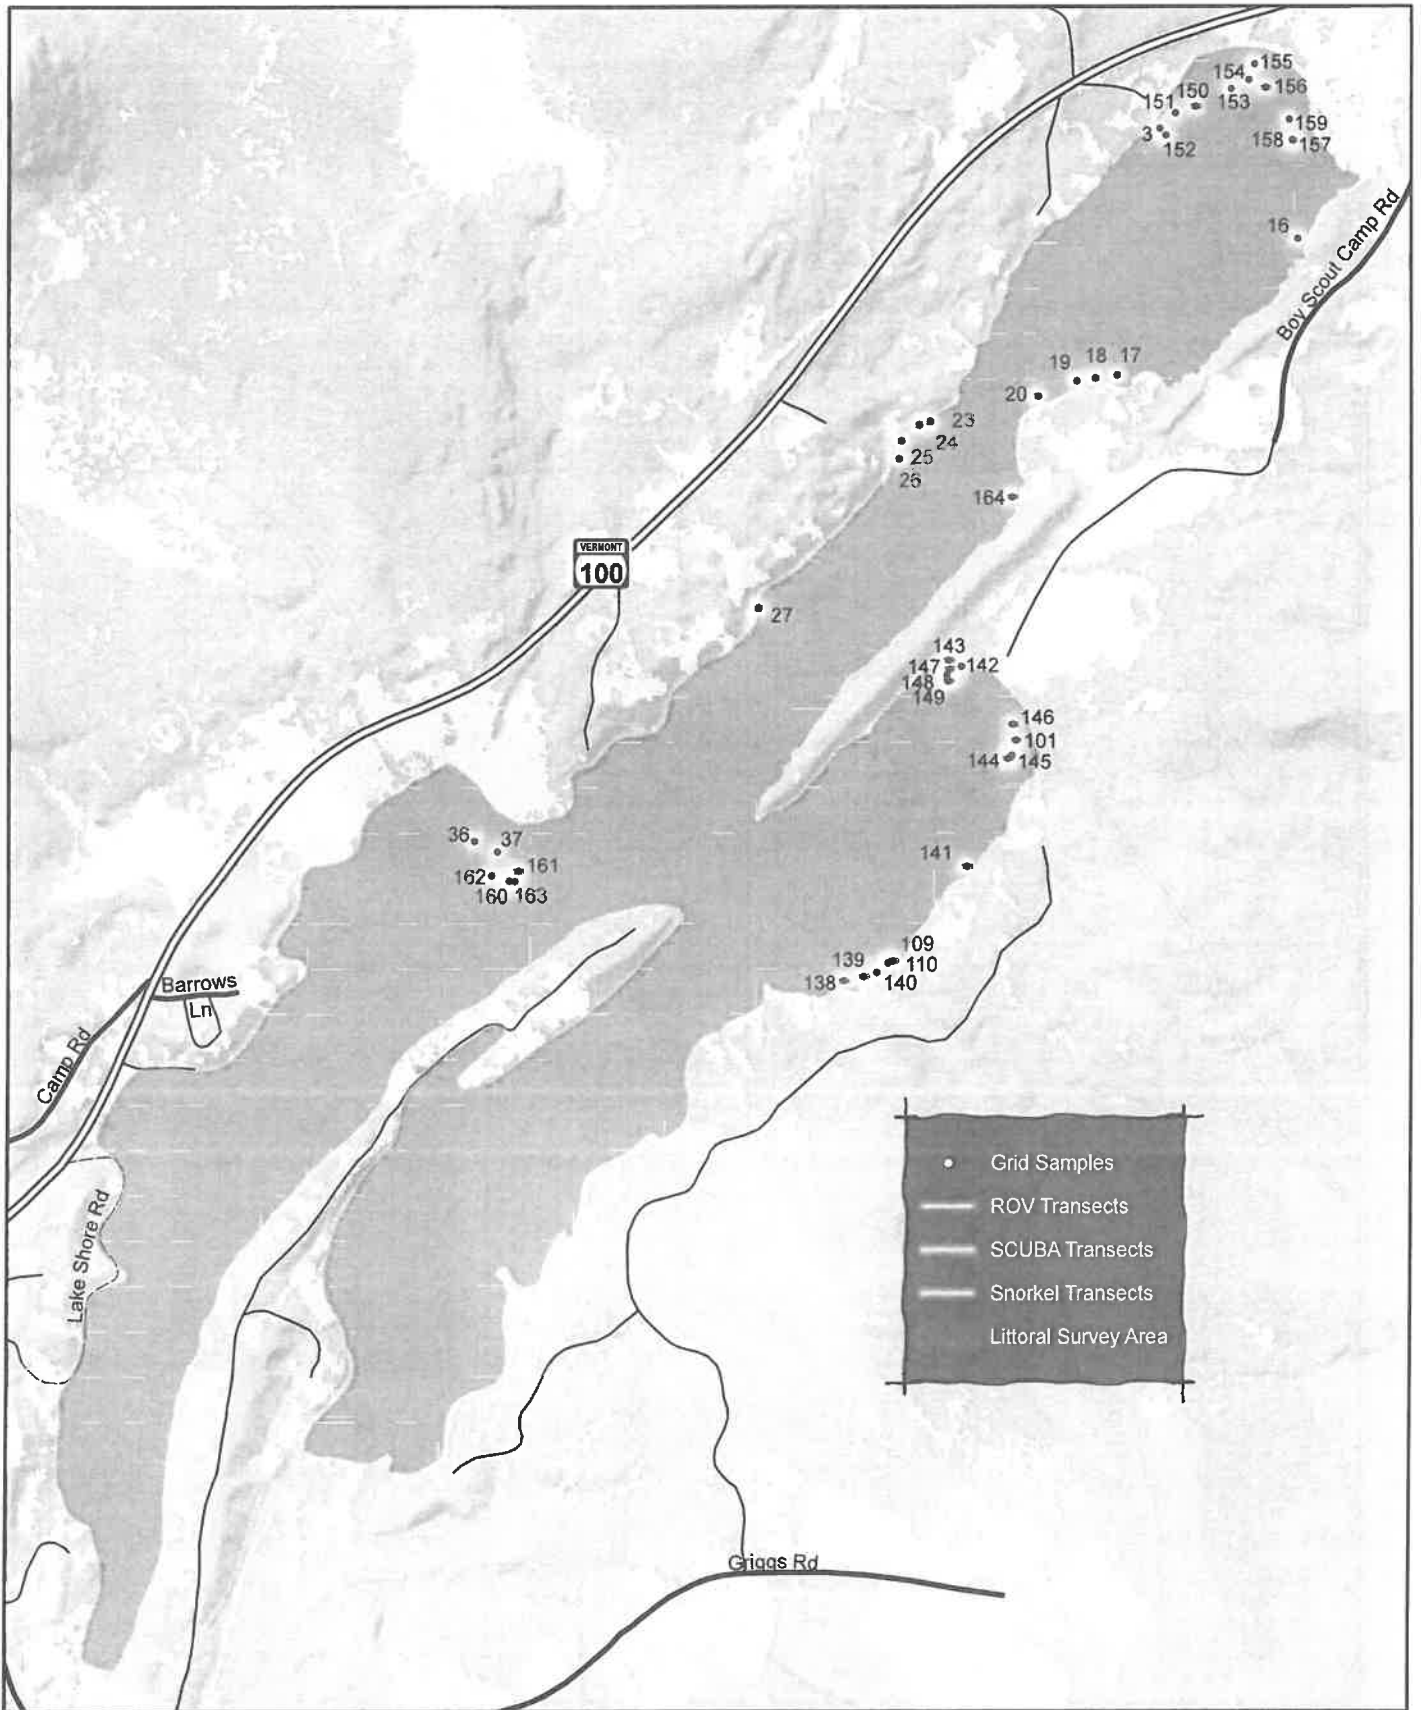
Lake Eden: Eurasian Watermilfoil 2022

A total of 43 locations of EWM were documented during the inventory. In some cases, only a single EWM plant was documented at a specific location, in other cases, as many as 120 plants were documented. Data for each of these locations is presented in the table in Appendix 1 and shown on the map in Appendix 2. Most of the occurrences were in the northeastern part of the lake. The southeastern half of the lake did not contain any rooted EWM, though a few floating fragments of this species were noted and removed. No EWM was discovered on the sampling rake while conducting the grid point sampling, though in 2 grid points, EWM was noted nearby. Grid point sampling is useful for conducting sampling in deeper waters and may detect EWM if there are dense infestations but did not prove a useful tool if EWM plants are sparsely distributed and abundant in low numbers.
